## TEST REPORT

No. : XMIN2510002430CM06\_EN

Sample Name : Rubber tile

### 1. Test Item: Wet Pendulum Test

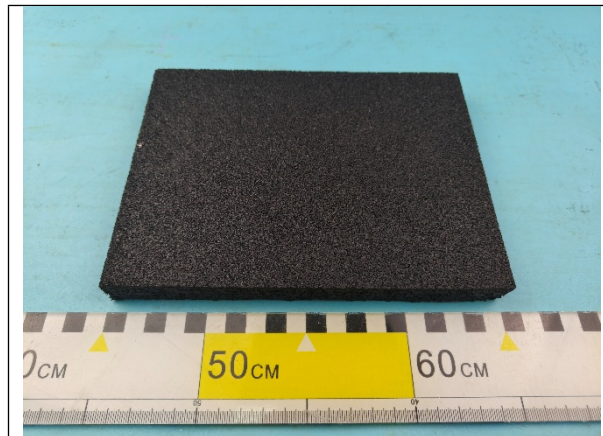
### Original Sample Photo:

Sample Description: See photo

Test surface: see photo
